# **INDOOR AIR QUALITY ASSESSMENT**

**Chicopee Public Safety Building  
Emergency Operations Center/Board of Health Offices  
15 Court Street  
Chicopee, Massachusetts**

Prepared by:  
Massachusetts Department of Public Health  
Bureau of Environmental Health Assessment  
Emergency Response/Indoor Air Quality Program  
November 2002

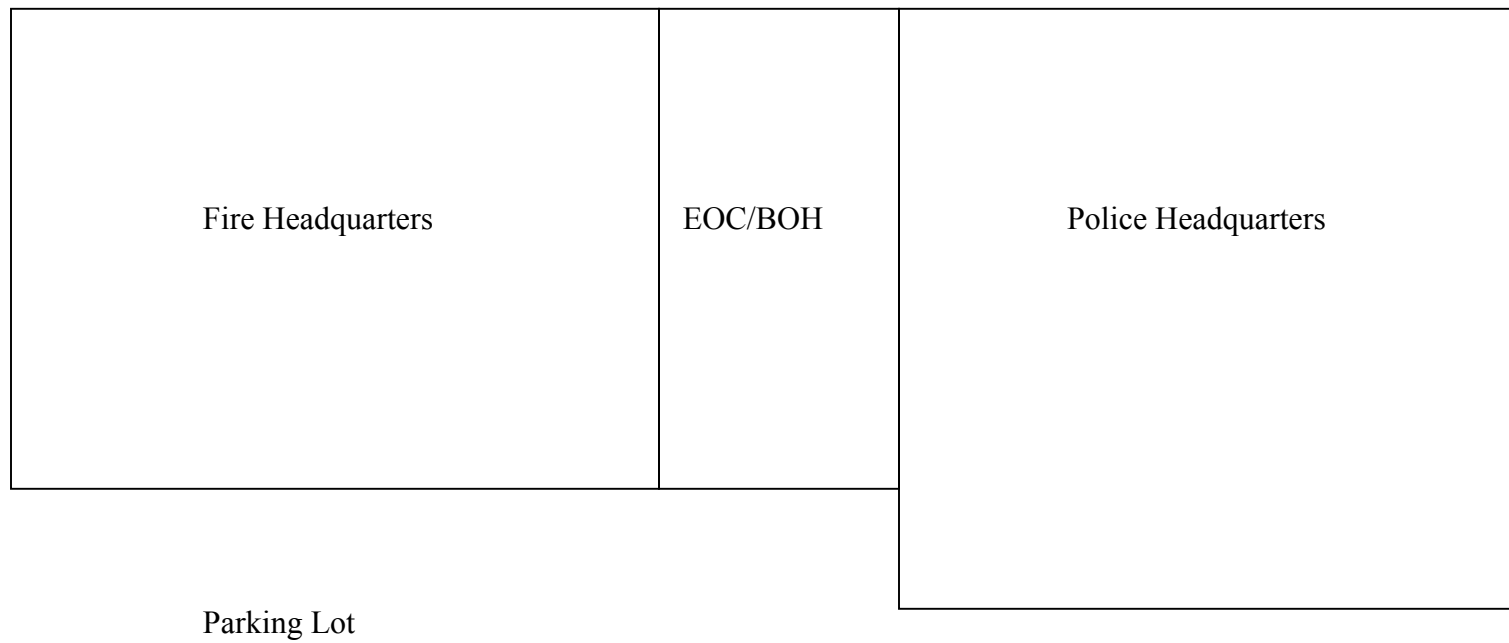
**Figure 1**  
**Configuration of Chicopee Public Safety Building**

The CPSC was constructed in 1976. The EOC/BOH is located on the ground floor of a two-story structure in the center of the CPSC, with the fire station on its north wall and the police station on its south wall (see Figure 1). The roof of the EOC/BOH also serves as a patio (see Picture 1). No openable windows exist in this part of the building.

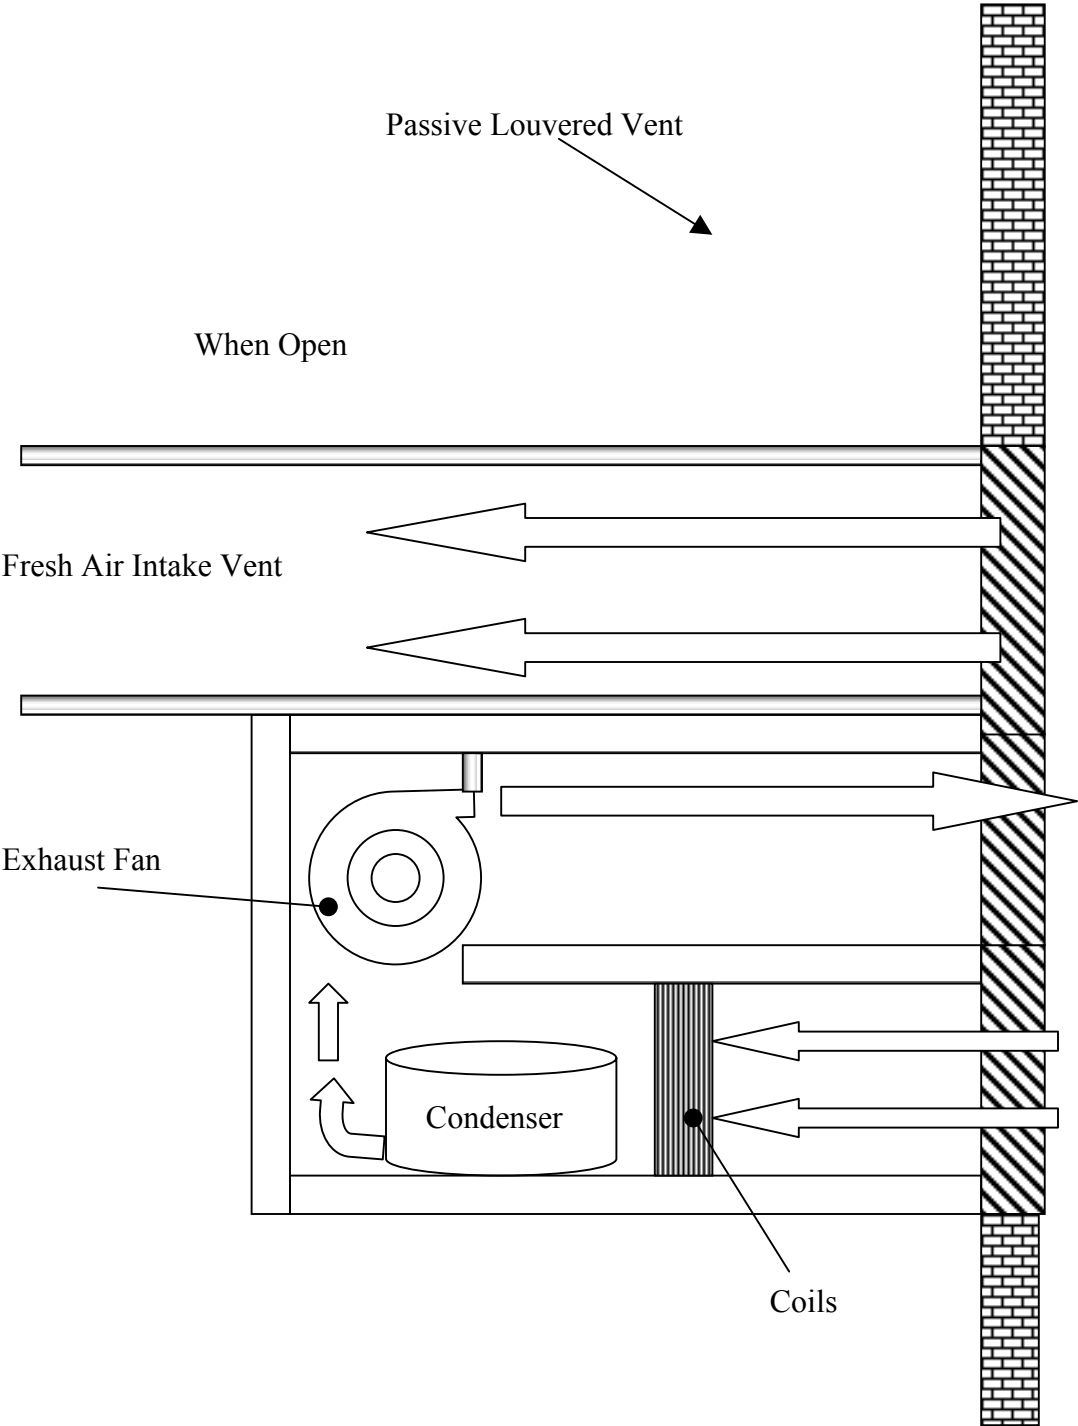
Figure 2

The AHU has two compartments with separate fresh air intakes. The upper compartment contains the heating/cooling coil. The lower cabinet contains the chiller that is activated during hot weather. Both cabinets contain drip pans to drain accumulated condensation from the coils and cold surfaces of the chiller. The purpose of the lower fresh air intake vent on the exterior of the building was to provide cooling for the Trane units' chiller compressor located in the base of the AHU (see Figure 2). The drip pans within the chamber containing the air conditioning equipment were heavily

Configuration of the AHU Closet and Trane AHUs
